YOUR ONESURVEY HOME REPORT

Juniperhill
Drumuillie
Boat of Garten
PH24 3BX

SINGLE SURVEY

Single Survey

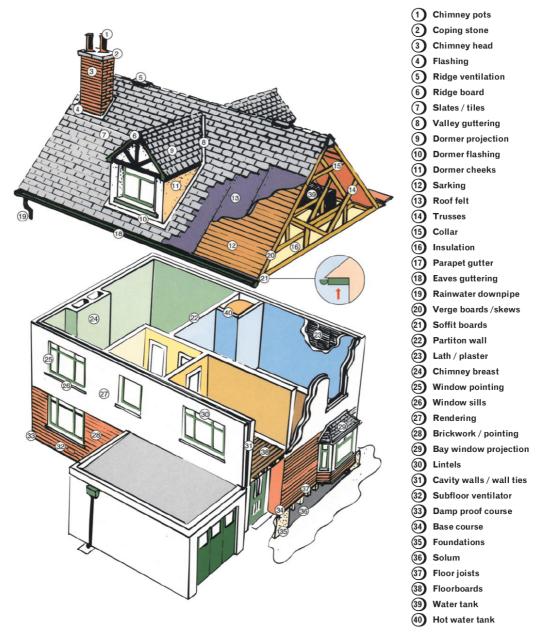
Sectional Diagram showing elements of a typical house

Reference may be made in this report to some or all of the above component parts of the property. This diagram may assist you in locating and understanding these items.
