Home Report

Single Survey

Property address	40 Corbett Place Aviemore PH22 1NZ
Customer	Ross and Clare Johnston
Customer address	40 Corbett Place Aviemore PH22 1NZ
Prepared by	Shepherd Chartered Surveyors
Date of inspection	29/10/2024

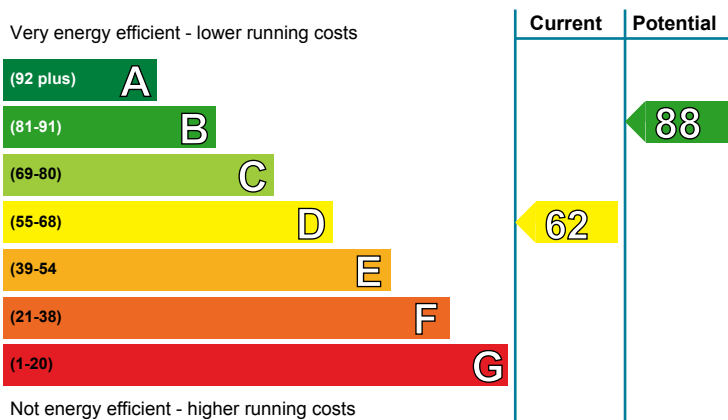
Energy Efficiency Rating

This graph shows the current efficiency of your home, taking into account both energy efficiency and fuel costs. The higher this rating, the lower your fuel bills are likely to be.

Your current rating is **band D (62)**. The average rating for EPCs in Scotland is **band D (61)**.

The potential rating shows the effect of undertaking all of the improvement measures listed within your recommendations report.

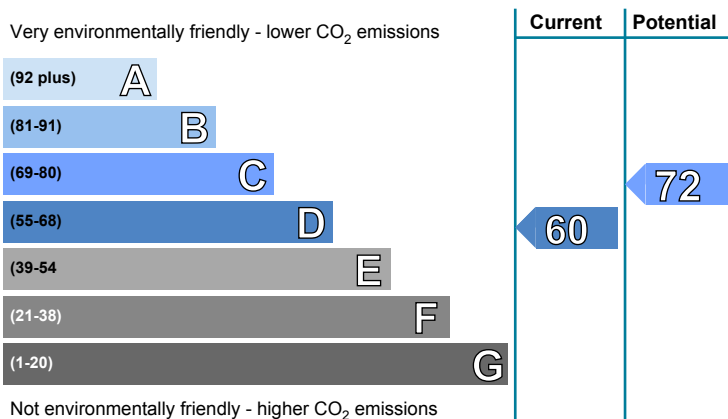
Environmental Impact (CO₂) Rating

This graph shows the effect of your home on the environment in terms of carbon dioxide (CO₂) emissions. The higher the rating, the less impact it has on the environment.

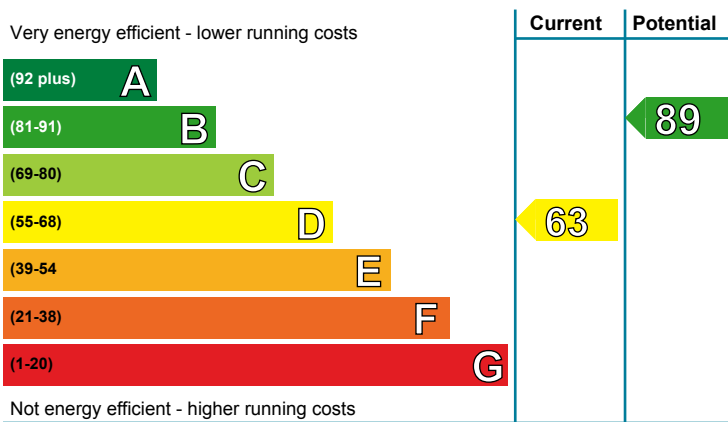
Energy Efficiency Rating

This graph shows the current efficiency of your home, taking into account both energy efficiency and fuel costs. The higher this rating, the lower your fuel bills are likely to be.

Your current rating is **band D (63)**. The average rating for EPCs in Scotland is **band D (61)**.

The potential rating shows the effect of undertaking all of the improvement measures listed within your recommendations report.

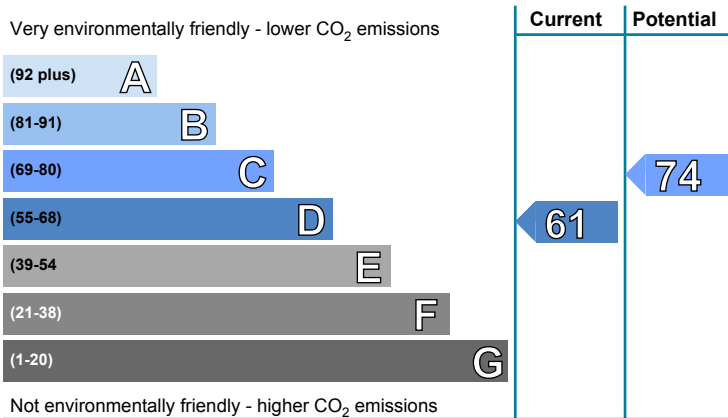
Environmental Impact (CO₂) Rating

This graph shows the effect of your home on the environment in terms of carbon dioxide (CO₂) emissions. The higher the rating, the less impact it has on the environment.
