YOUR ONESURVEY HOME REPORT

Craigmore 6 Skye Of Curr Road Dulnain Bridge, Grantown-on-Spey PH26 3PA

SINGLE Survey

Single Survey

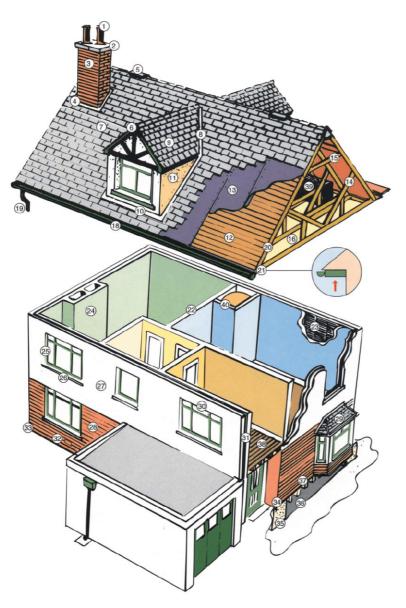
Sectional Diagram showing elements of a typical house

Reference may be made in this report to some or all of the above component parts of the property. This diagram may assist you in locating and understanding these items.

Coping stone 2 3 Chimney head 4 Flashing 5 **Ridge ventilation** 6 Ridge board 7 Slates / tiles 8 Valley guttering **9** Dormer projection 10 Dormer flashing **Dormer cheeks** 12 Sarking (13) Roof felt (14) Trusses (15) Collar 16 Insulation 17 Parapet gutter (18) Eaves guttering (19) Rainwater downpipe (20) Verge boards / skews (21) Soffit boards 22 Partiton wall 23 Lath / plaster (24) Chimney breast (25) Window pointing (26) Window sills (27) Rendering (28) Brickwork / pointing (29) Bay window projection 30 Lintels (31) Cavity walls / wall ties 32 Subfloor ventilator 33 Damp proof course (34) Base course **35** Foundations (36) Solum
