YOUR ONESURVEY HOME REPORT

67 Strathspey Drive Grantown-on-Spey PH26 3EY

Single Survey

Customer	Alan Smith & Stephanie Grant	
Selling address	67 Strathspey Drive	
	Grantown-on-Spey	
	PH26 3EY	
Date of Inspection	05/02/2025	
Prepared by	Calum Riach, MRICS D M Hall - Inverness

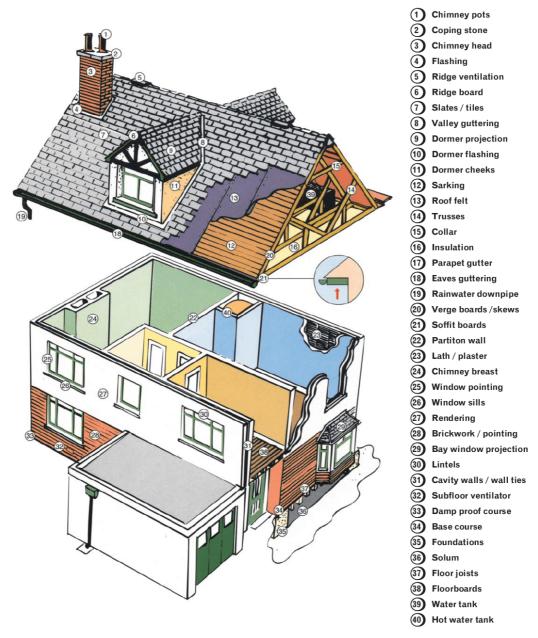
Sectional Diagram showing elements of a typical house

Reference may be made in this report to some or all of the above component parts of the property. This diagram may assist you in locating and understanding these items.
