# HOME REPORT

UPPER COULL GLENLIVET

BALLINDALLOCH  
AB37 9DS

# Energy Performance Certificate (EPC)

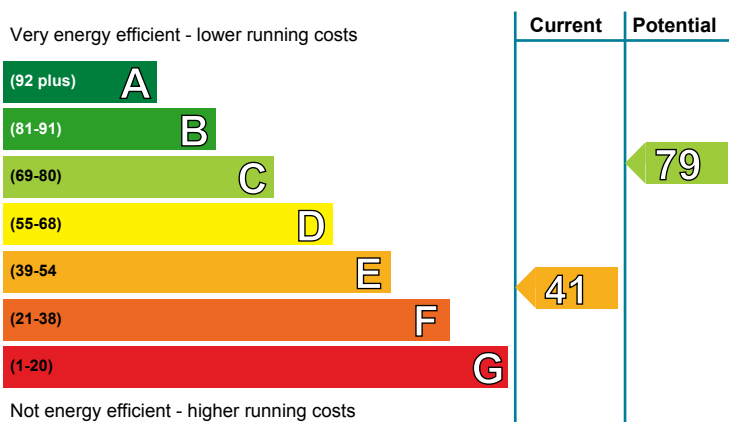
## Energy Efficiency Rating

This graph shows the current efficiency of your home, taking into account both energy efficiency and fuel costs. The higher this rating, the lower your fuel bills are likely to be.

Your current rating is **band E (41)**. The average rating for EPCs in Scotland is **band D (61)**.

The potential rating shows the effect of undertaking all of the improvement measures listed within your recommendations report.

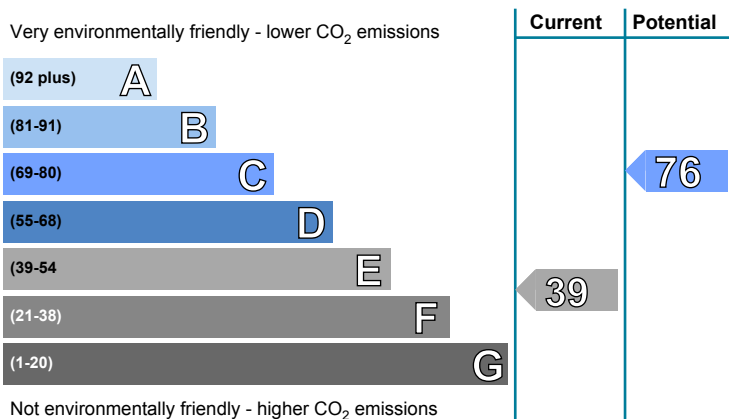
## Environmental Impact (CO<sub>2</sub>) Rating

This graph shows the effect of your home on the environment in terms of carbon dioxide (CO<sub>2</sub>) emissions. The higher the rating, the less impact it has on the environment.

Your current rating is **band E (39)**. The average rating for EPCs in Scotland is **band D (59)**.

The potential rating shows the effect of undertaking all of the improvement measures listed within your recommendations report.
